# Manhole Inspection Summary

Manhole # S21K\_\_042MH

Insp Date: **4/3/08 9:59 AM**

**Location** Address: **334 fulton-addison alley**

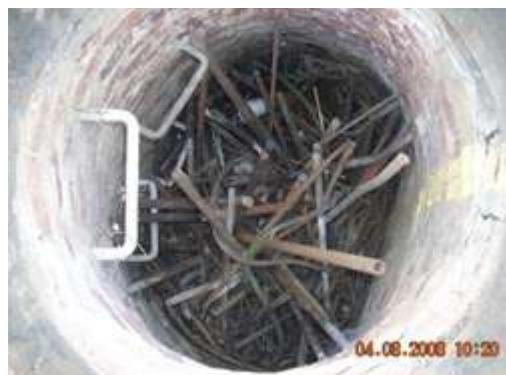
Defect 3

above alley finish grade

debris in channel

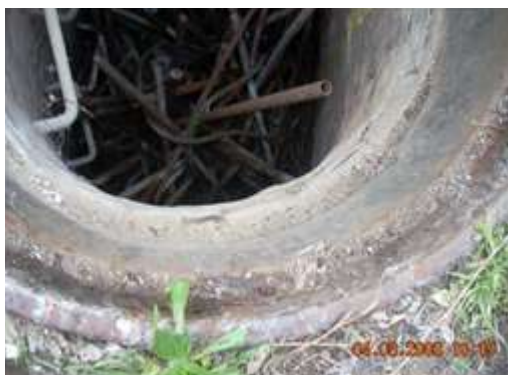
Defect 1

**Frame** Offset: **2** (in.) Condition: ☒ Sound ☐ Cracked ☐ Leaks

frame offset

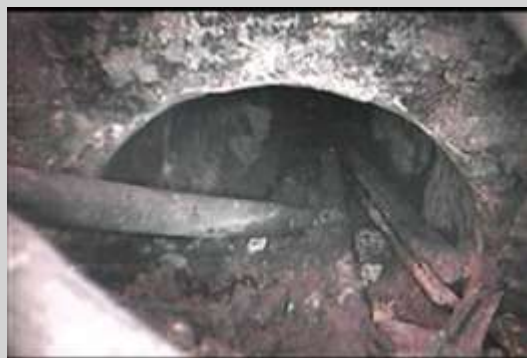
12 O'Clock Outflow

8 in. Circular Gravity Sewer  
Pipe Out @ 12 O'Clock

Deposits: ☐ None ☒ **Mud** ☐ Sludge ☒ **Debris** ☐ Grease

Silt Depth: **2** (in.) Deposits Extent: **Light**
